NASA Contractor Report 165784

EFFECT OF MATRIX RESIN ON THE IMPACT FRACTURE  
CHARACTERISTICS OF GRAPHITE-EPOXY LAMINATES

P. E. Hertzberg, B. W. Smith, and A. G. Miller

Boeing Commercial Airplane Company  
Seattle, Washington

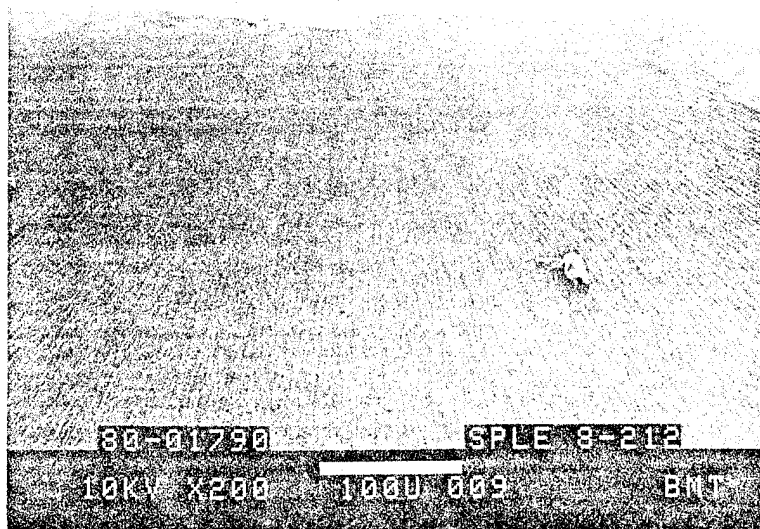
Narmco 5208 (fig. 7) is a tetraglycidylmethyle dianiline (TGMDA)-diaminodiphenylsulfone (DDS), 177°C (350°F) curing epoxy with good high-temperature properties, low strain to failure, and brittle fracture behavior. This brittle behavior is manifested in the smooth, glassy cleavage planes found in the fracture face, as well as the well-defined origin zones and transverse cleavage planes perpendicular to the direction of crack propagation. Figure 7 describes the classically brittle case, and the features seen at low magnification continue as increasing magnification is used (figs. 9 and 10). There is little ductility in this material and no deliberate introduction of second-phase elastomer or elastomer modification of any kind.

Figure 7. Neat Resin Fracture, Narmco 5208 (200X)

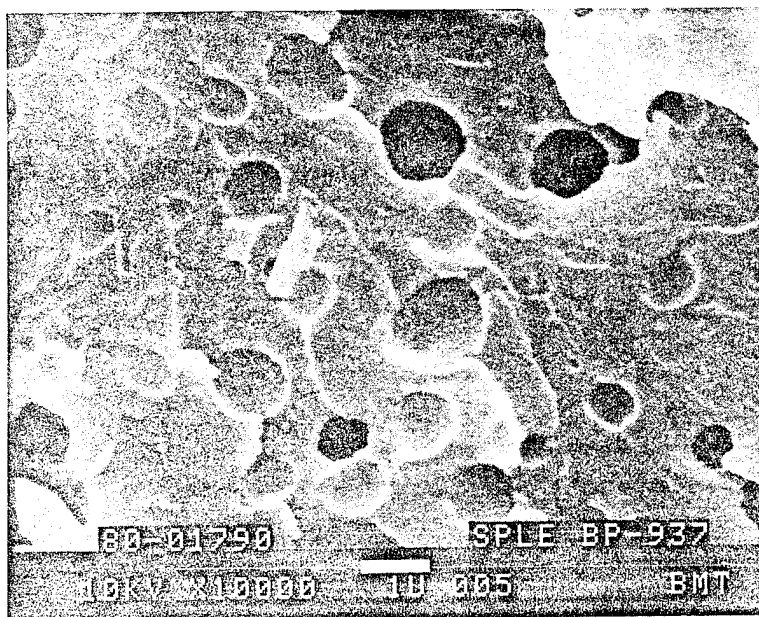
Figure 13. Elastomer Deformation Pits, Cycom 937 (19X)

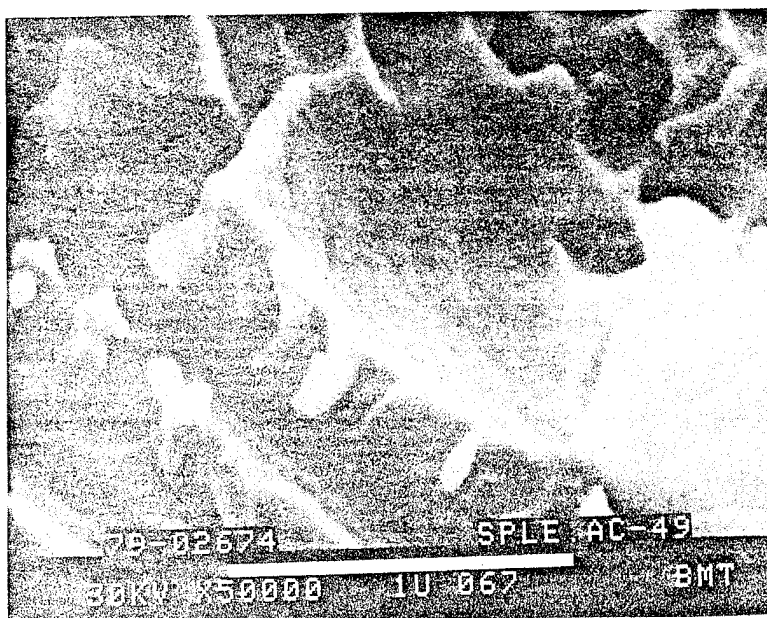
Figure 14. Elastomer Deformation Pits, Cycom 937 (500X)

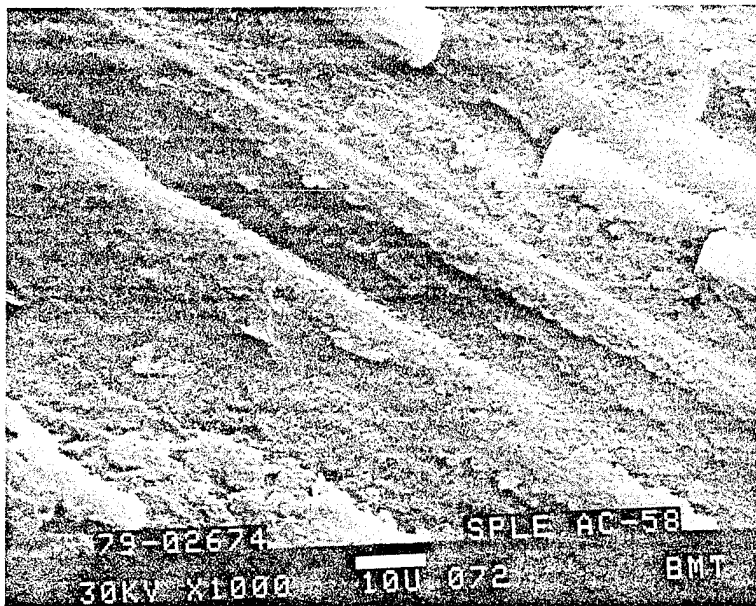
Figure 27. Static Notched Tension Failure, Origin, Cycom 937 (1000X)

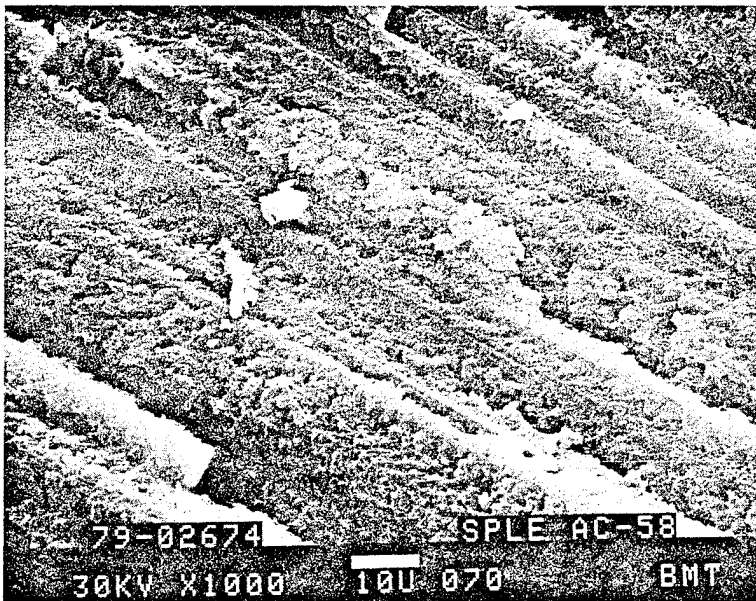
Figure 28. Static Notched Tension Failure, Propagation Zone, Cycom 937 (1000X)

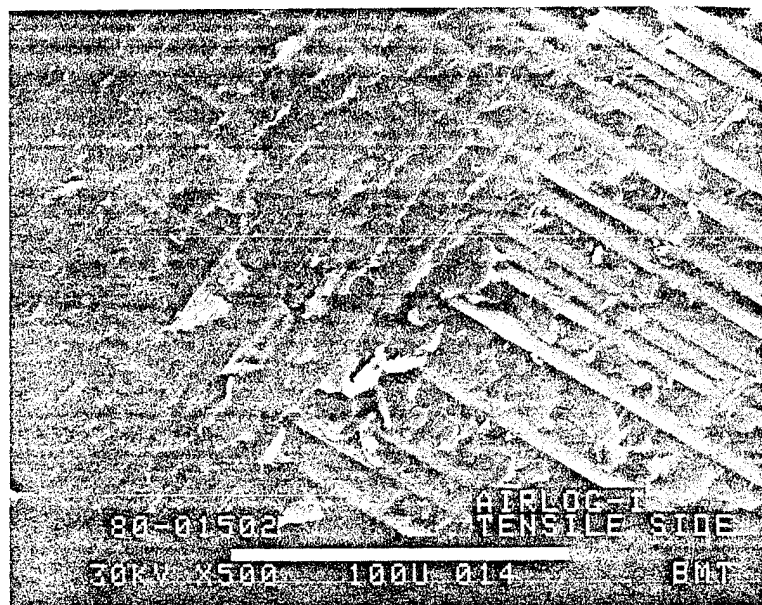
Figure 31. Plastic Deformation of Resin Around Fibers, Air Logistics 1 (500X)

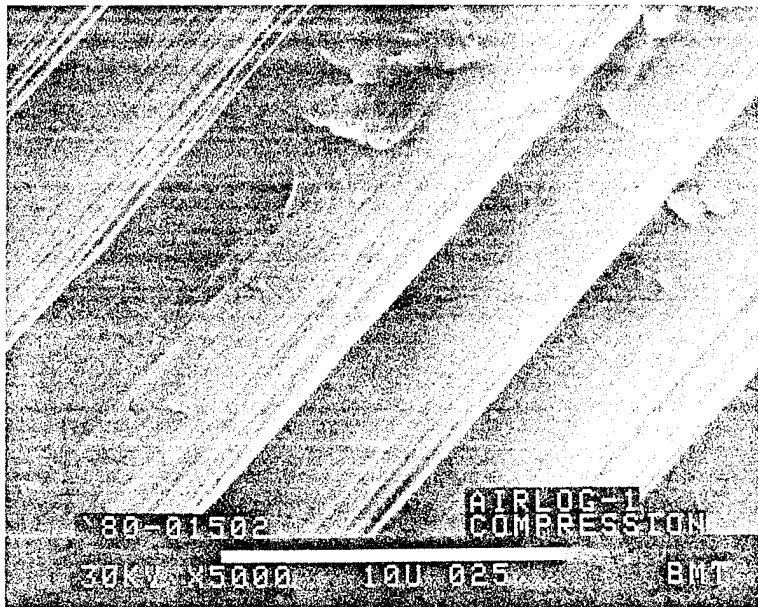
Figure 39. Fiber-Matrix Bond, Compression Side, Air Logistics 1 (5000X)

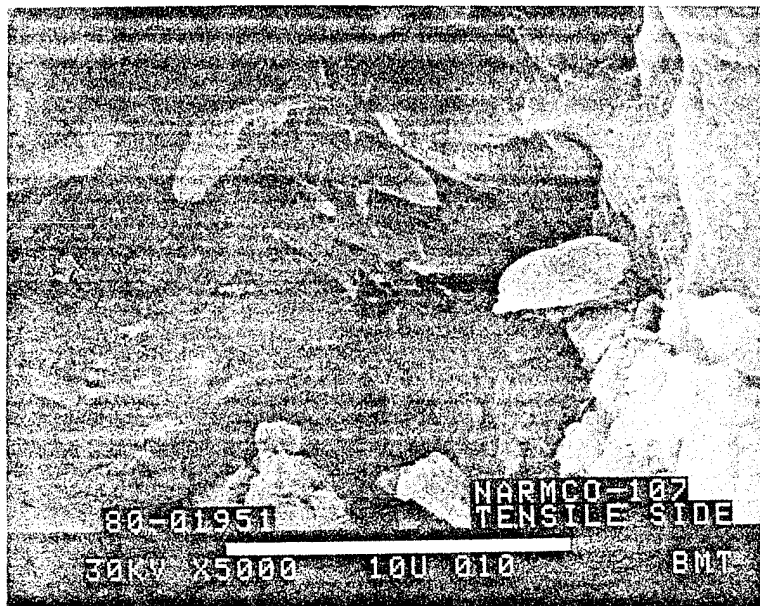
Note flow lines in resin

Figure 43. Flow of Resin Under Shear Loads, Narmco 107 (5000X)

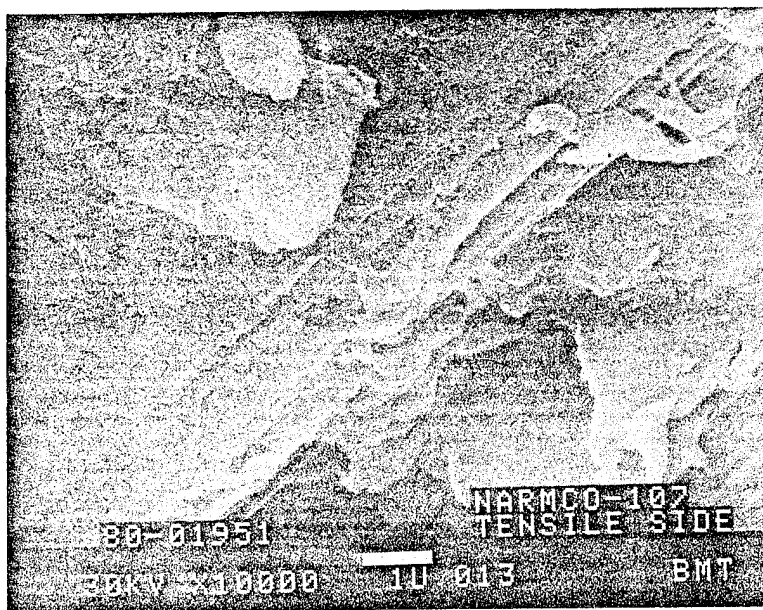
Figure 46. Resin-Fiber Bonds, Narmco 107 (10,000X)

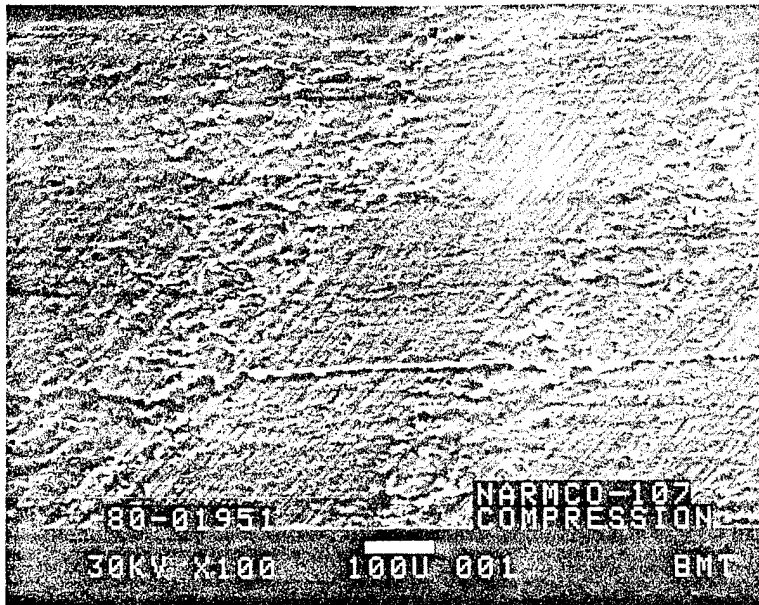
Note resin deformation.

Figure 47. Compression-Loaded Shear, Narmco 107 (100X)

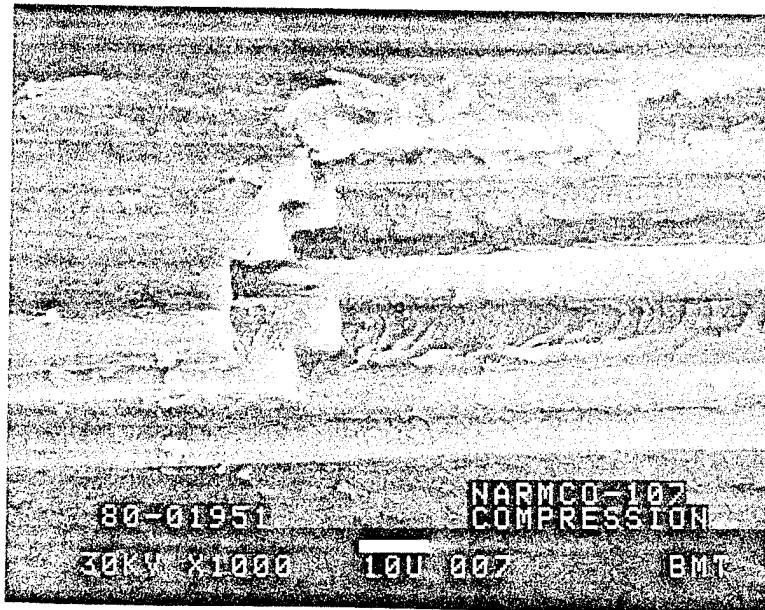
Figure 51. Transverse Ply Fracture, Compression Side, Narmco 107 (1000X)

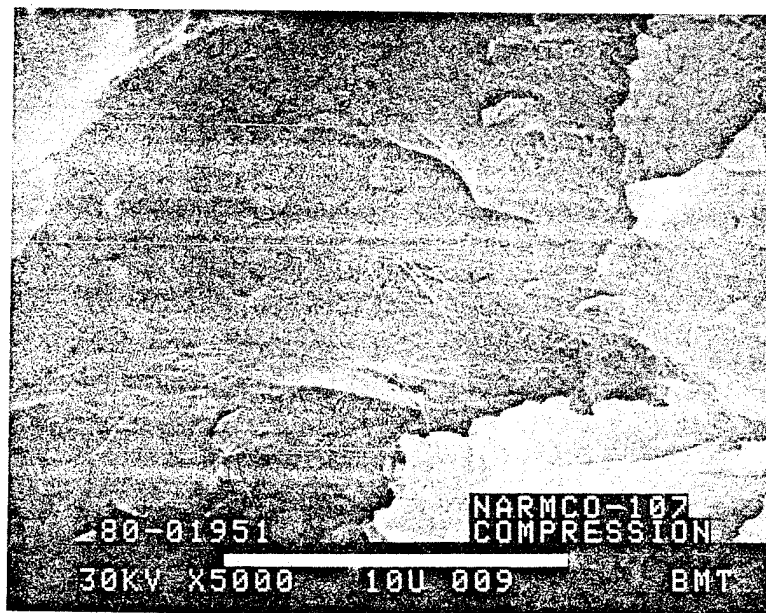
Figure 52. Hairy Skin Fracture Appearance, Shear-Loaded, Narmco 107 (5000X)

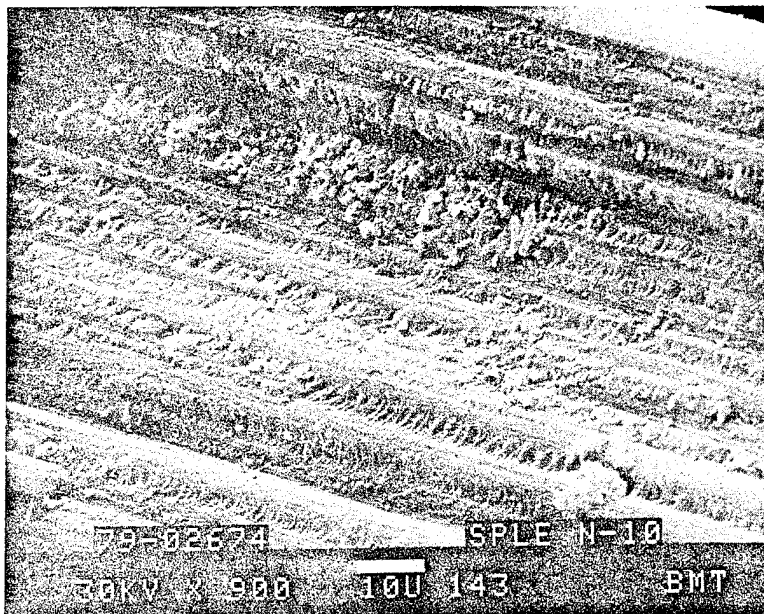
Figures 55 and 56 show higher magnification views of this brittle deformation in two separate areas. For comparison, Figures 57 and 58 show typical shear failures of a brittle resin system, Narmco 5208, in a graphite composite manufactured using tape in a  $\pm 45$ -deg layup and failed in tension. Note the similarity of resin fracture features between the fibers of Figures 57 and 58 and the resin fracture of Figures 55 and 56. Recognition must be given to the scale of the features. The brittle cleavage formations of Ciba 4 are much larger and do show some slight rounding, indicating that limited plastic deformation has occurred. This would be expected, since the photomicrographs suggest that Ciba 4 is considerably tougher, based on apparent impact damage, than Narmco 5208.

Figure 57. Notched Shear Static Failure, Narmco 5208 (900X)

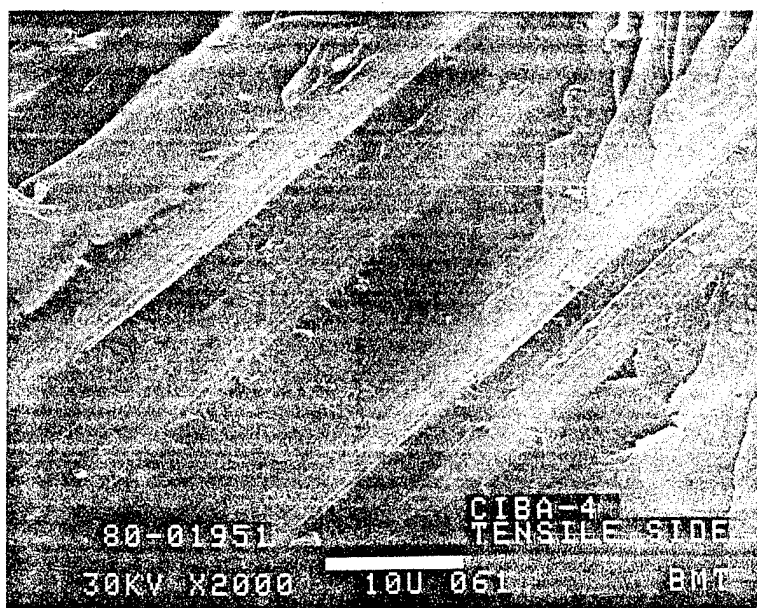
Resin tension fracture, viewed from a transverse crack in a tension-loaded 90-deg ply, is shown in Figures 59 and 60. As in the case of the shear appearance, the ultimate separation mechanism is cleavage. However, plastic flow of the bulk materials appears to have occurred before separation. This is evident when Figures 59 and 60 are compared to Figures 61 and 62, a 90-deg tension failure of Narmco 5208. Care must be taken when making comparisons due to the different magnifications, but the similarity of features is evident.

Figure 59. Resin Tension Fracture, Ciba 4 (2000X)

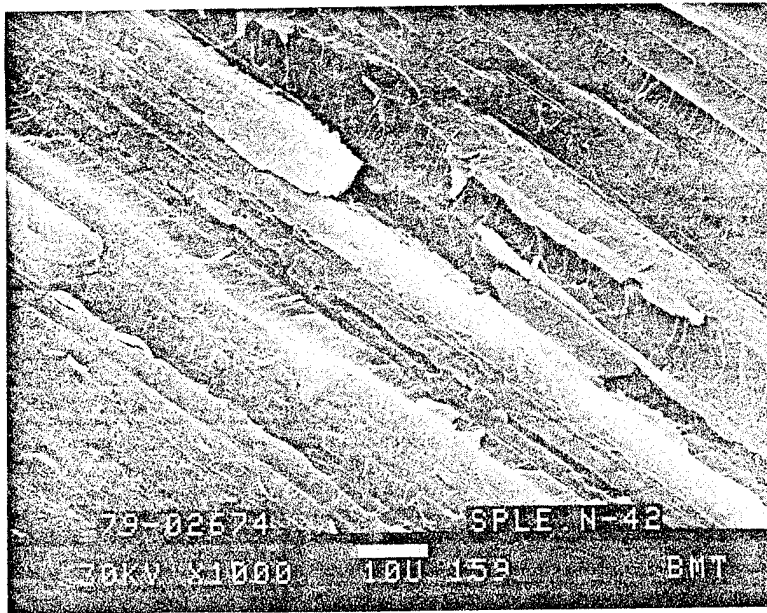
Figure 62. 90-deg Tension Failure, Propagation Zone, Narmco 5208 (1000X)

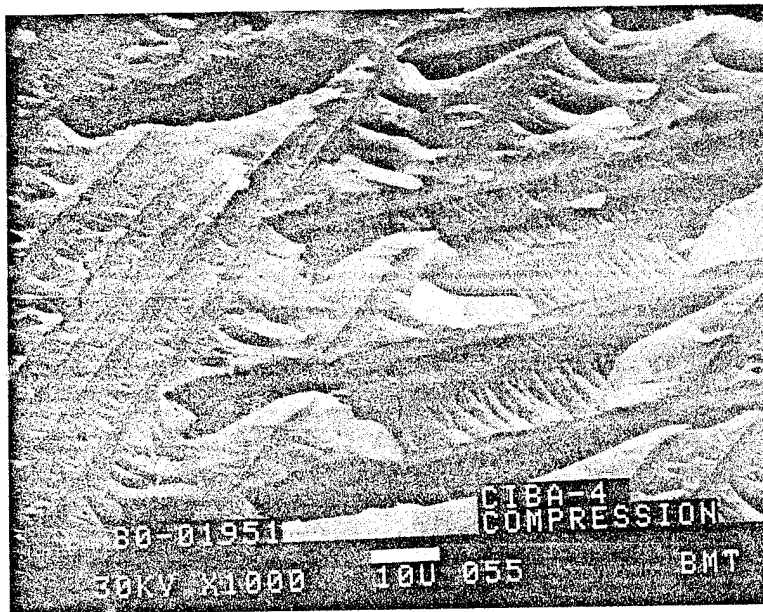
Figures 64, 65, and 66 are photographs of interlaminar shear faces from the compression end of the specimen. Comparison with Figures 55 and 56 shows that the mechanism of shear deformation is uniform across the specimen.

Figure 66. Compression-Loaded Interlaminar Shear Failure, Ciba 4 (1000X)

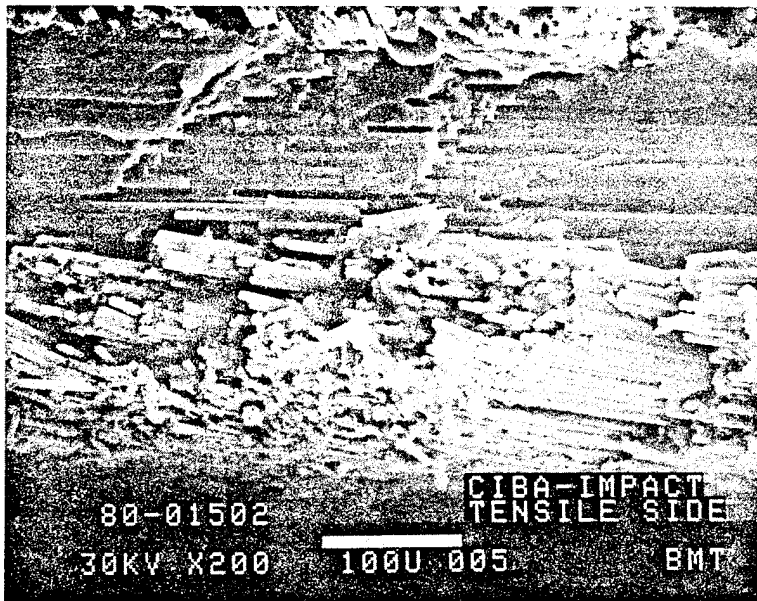
Figures 67 and 68 show tension intraply failure of 0/ $\pm$ 45-deg plies in Ciba IM. Ciba IM has been determined to fail by fracture mechanism 3, which is shear-dominated mixed-mode cracking. This mode, and the specimens falling into it, exhibited the most damage as measured by visual evaluation of the polished microstructures. This category includes the two industry standard 177°C (350°F) curing materials, Narmco 5208 and Hercules 3501-5A.

Figure 68. Typical Crossply Failure, Significant Pullout, Ciba 1M (200X)

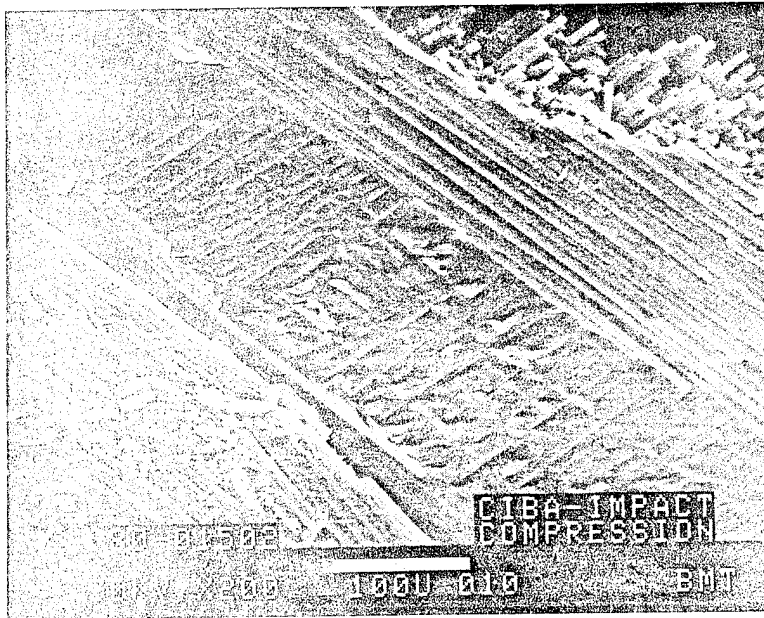
Figure 73 shows delamination planes on the compression side of the specimen, as well as a compression-loaded,  $\pm 45$ -deg ply and a pulled-out tension-loaded crossply. The interface shown was at the neutral axis of the impact-loaded specimen and had only shear loading. A higher magnification view is shown in Figure 74. The light spots on the photograph are an artifact of the photographic process. The fracture features on these planes are similar to those of the delamination faces on the tension side, but are much less distinct. Also, considerable secondary cracking out of the photograph plane has occurred, penetrating into the underlying area of the fibers. It is not clear whether such secondary cracks emanated from or penetrated into the exposed delamination surface. However, the relatively regular spacing of these transverse tension cracks suggests that they propagated into the exposed delamination surface. Figures 75 and 76 show higher magnification views of some similar planes. Figure 76 also shows the influence of voids on the fracture, since the crack has separated several voids in this photograph. The voids do not act as origins for the fracture, but simply function as free surfaces. As such, they would artificially lower the fracture toughness, because no energy would be required during cracking to create the void surface.

Figure 73. Neutral Axis, Ciba 1M (200X)

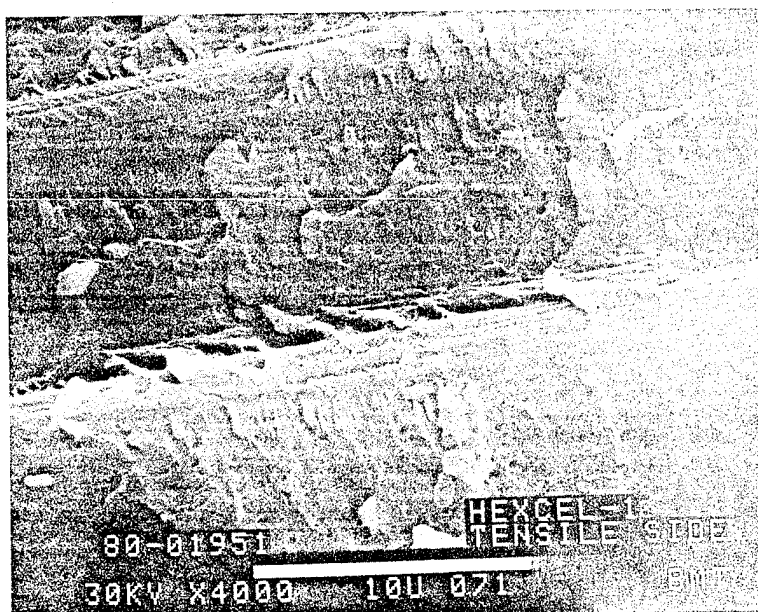
The pit size distribution remains narrow throughout the specimen, as can be seen by comparing Figures 79 and 80 with Figures 81 and 82, which are photographs of a corresponding shear plane from the compression side of the specimen and exhibit the same pitted appearance. The pits conform to the plastic flow directions of the base resin, which supports the supposition that the pits are voids, or at least were created before the ultimate separation of the fracture faces.

Fiber-matrix bonding of Hexcel I seems to be adequate for the impact case. This is shown in Figures 79 and 81. The conditions shown in these photographs are typical of the entire fracture appearance.

Figure 79. Good Resin Ductility, Transverse Tension Loading, Hexcel 1 (4000X)

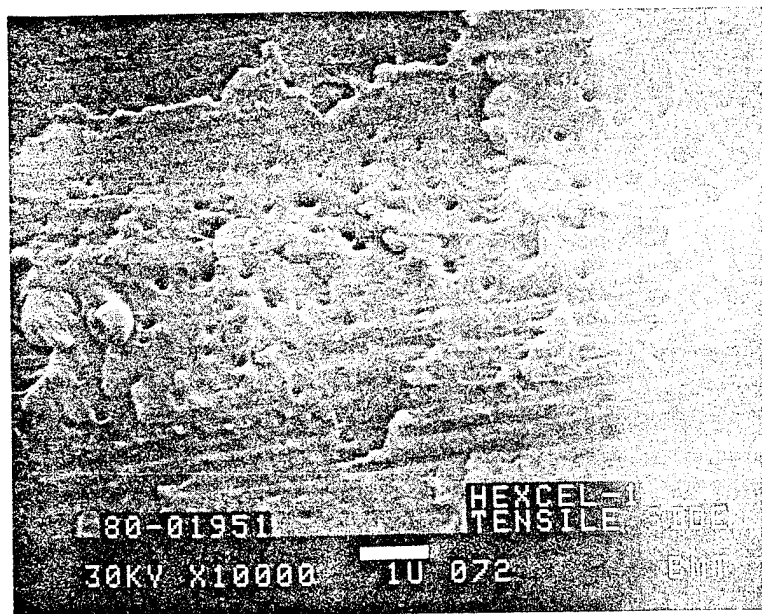
Figure 80. Resin Flow With Pits, Hexcel 1 (10,000X)

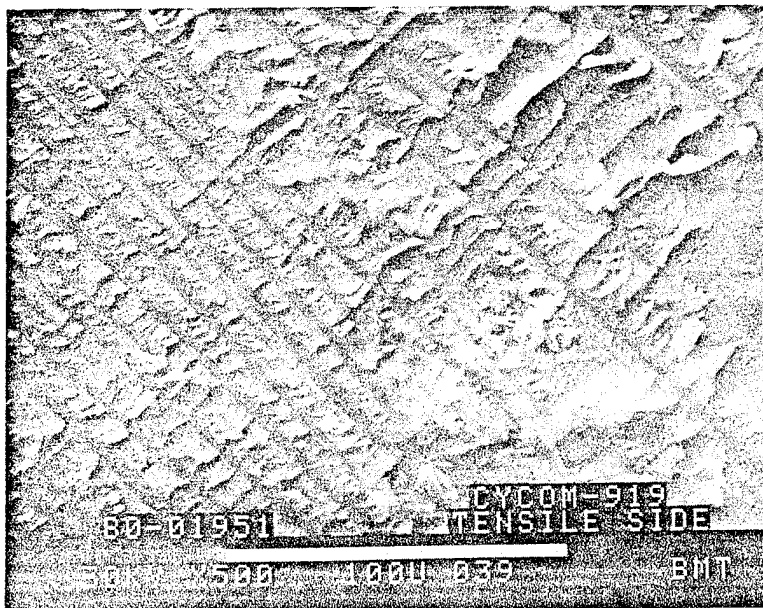
Figure 86. Apparent Brittle Fracture, Cycom 919 (500X)

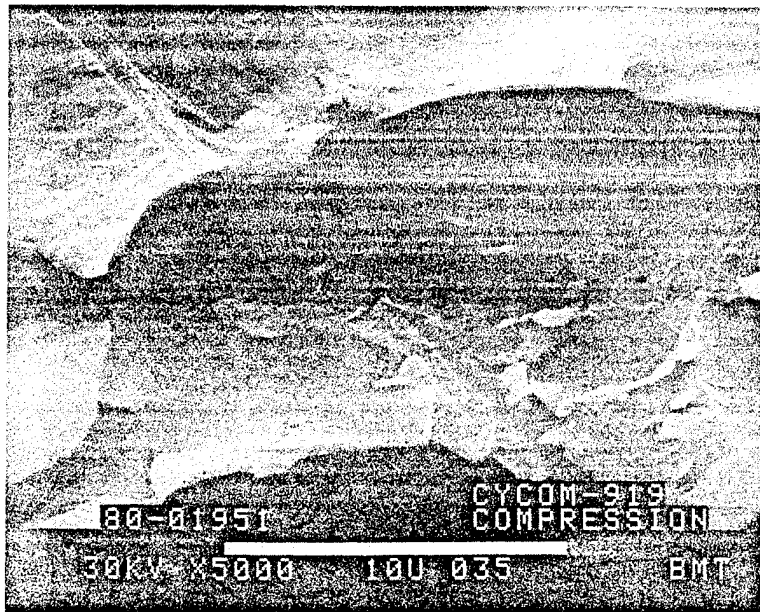
Fiber-matrix bonding is adequate in Cycom 919, as shown in Figures 90, 91, and 92. The fiber surfaces shown in this figure are coated with a thin layer of resin, some of which is plastically deformed.

Figure 91. Resin-Fiber Bond, Cycom 919 (5000X)

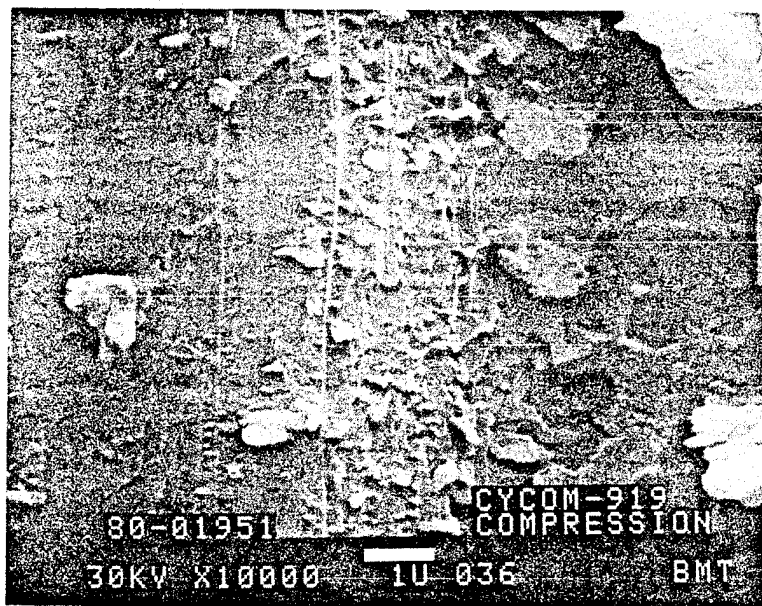
Figure 92. Resin-Fiber Bond, Exposed Fibers, Cycom 919 (10,000X)

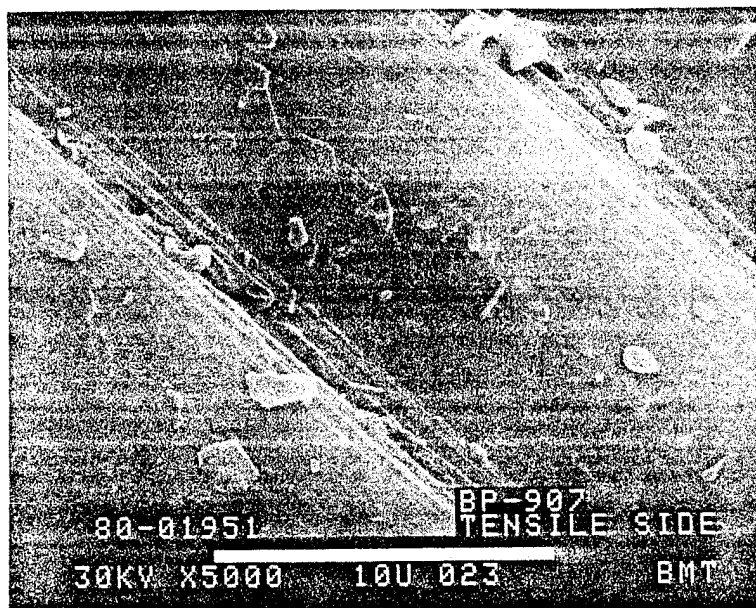
The basic microscopic fracture mechanism appears to be the same in both the high- and low-resin-content materials. This conclusion is based on comparison of the two photographs in Figures 99 and 100. However, the fact that insufficient material may be available for the complete operation of this fracture mechanism may impair its efficiency as a toughening agent, as shown by Figures 101 and 102. The elongation of the resin under stress is clearly shown by Figure 102, but the formation of the large, deformed bodies seems to require the presence of greater amounts of resin. This would be manifested in an apparent increase of impact toughness, since the energy required to deform greater amounts of resin would necessarily be higher than that required for a lesser amount of the same resin.

Figure 99. Microscopic Fracture Mechanism, BP-907 (5000X)

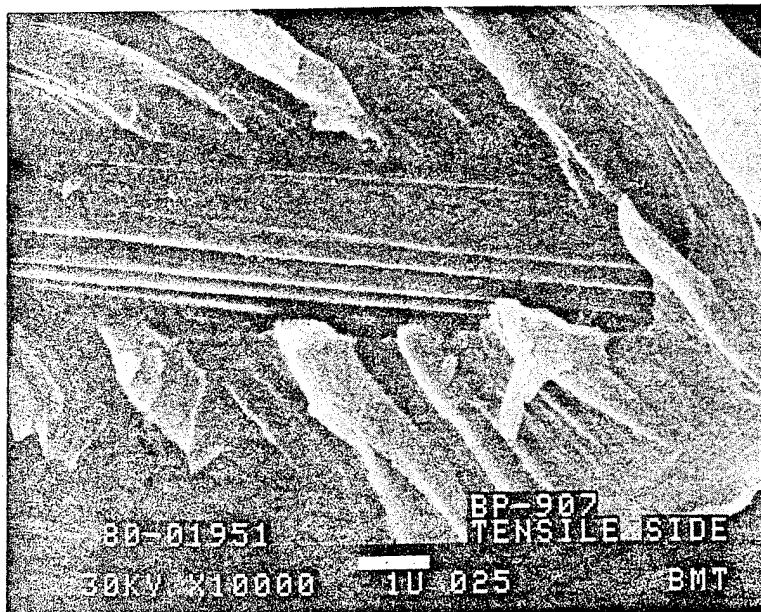
Figures 101 and 102 also show that the interface properties of BP-907 are not affected by resin content and that complete wetting of the fibers occurs despite the lower resin content of BP-907-LR.

Figure 101. Resin-Fiber Bond, BP-907 (10,000X)

Note large elongated resin blocks.

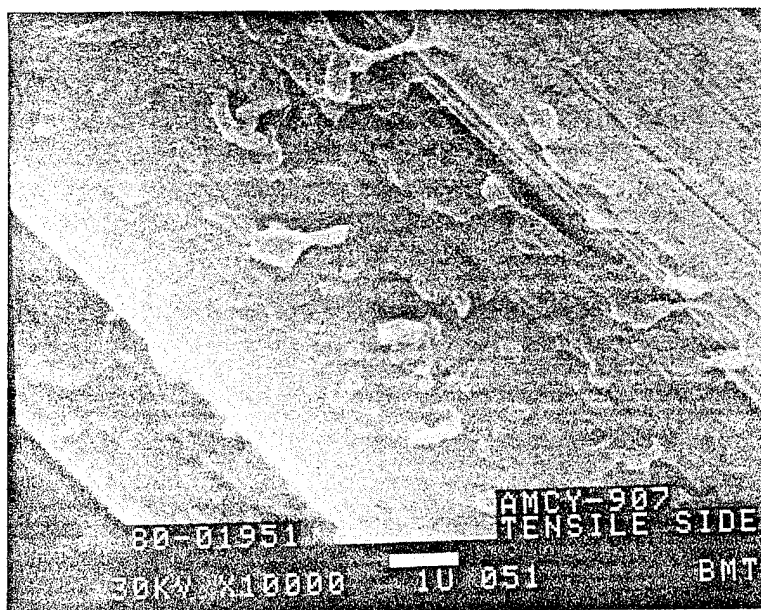
Figure 102. Resin-Fiber Bond, BP-907-LR (10,000X)

Note lack of large ductile flow.

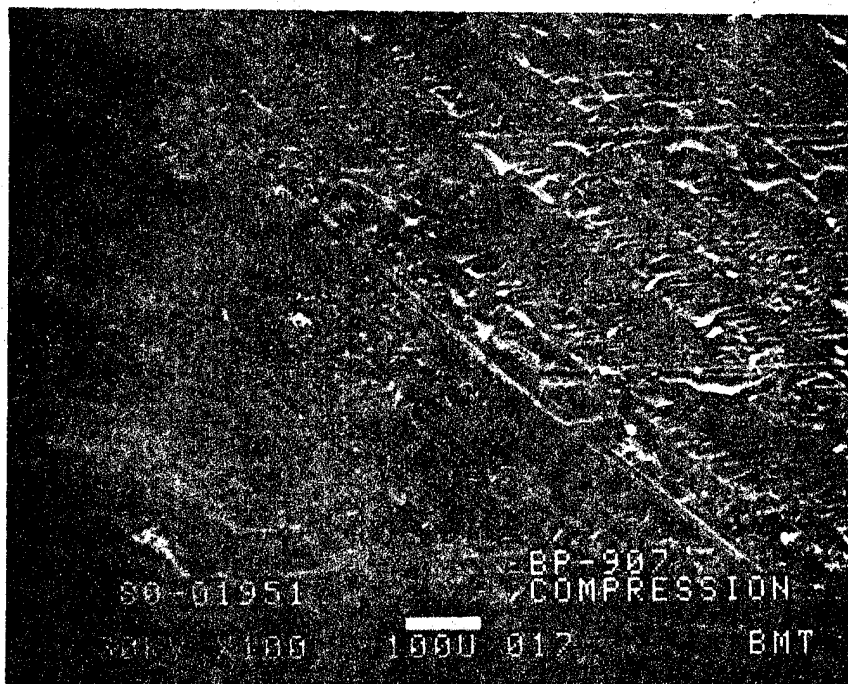
The differences in apparent ductility also extend to the compression-loaded interfaces. This is seen in Figures 103 through 108. These photographs show, as on the tension side, that the same deformation mechanism applies to the entire specimen, but that the lower resin content reduces the material available for this mechanism to act on. This would result in a lower apparent toughness for the materials with lower resin content.

Figure 103. Compression-Loaded Shear Delamination, BP-907 (100X)

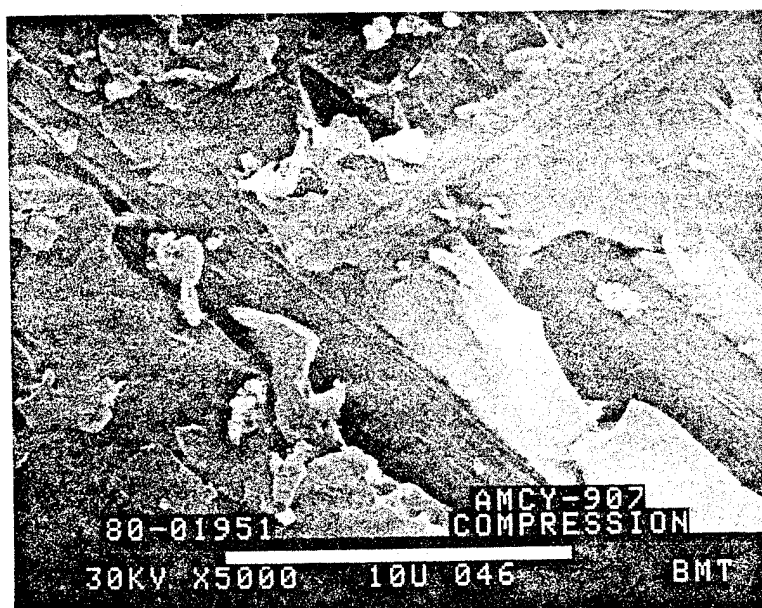
Figure 108. Microscopic Fracture Appearance, BP-907-LR (5000X)

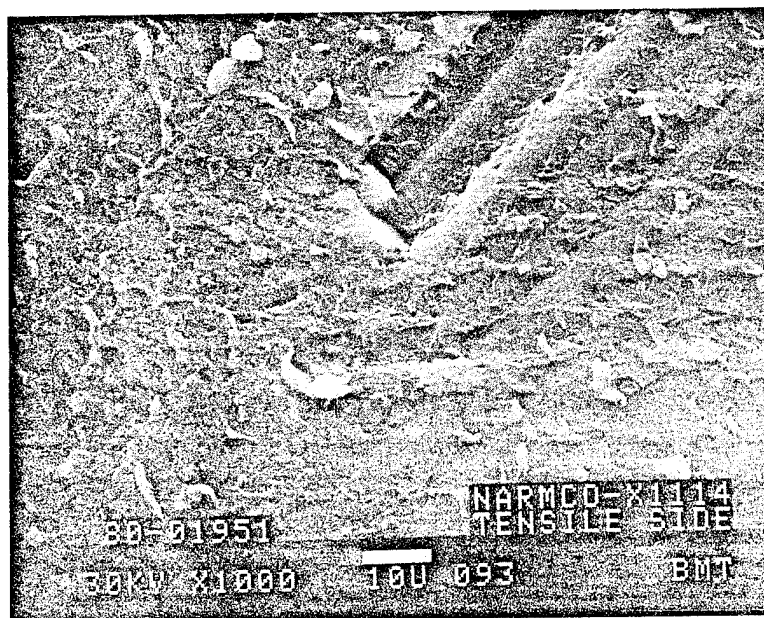
Considerable plastic flow is indeed found upon examination of the separated surfaces. This deformation is shown in Figures 109 through 114. These photographs, particularly Figures 111 through 114, show that there is virtually no brittle fracture or cleavage on the fracture planes. All of the resin shows an almost gummy appearance, as if capable of extreme strain. The fact that this composite has a  $T_g$  of only  $46^\circ\text{C}$  ( $114^\circ\text{F}$ ) may be a factor in this extreme plastic flow. Figure 114 shows that bonding to the fibers is extremely good for this system, and Figure 113 shows that even tension fiber failure does not translate into a failure of the surrounding resin.

Note lack of propagation of fiber failure.

Figure 113. Delamination Face, Narmco X1114 (1000X)

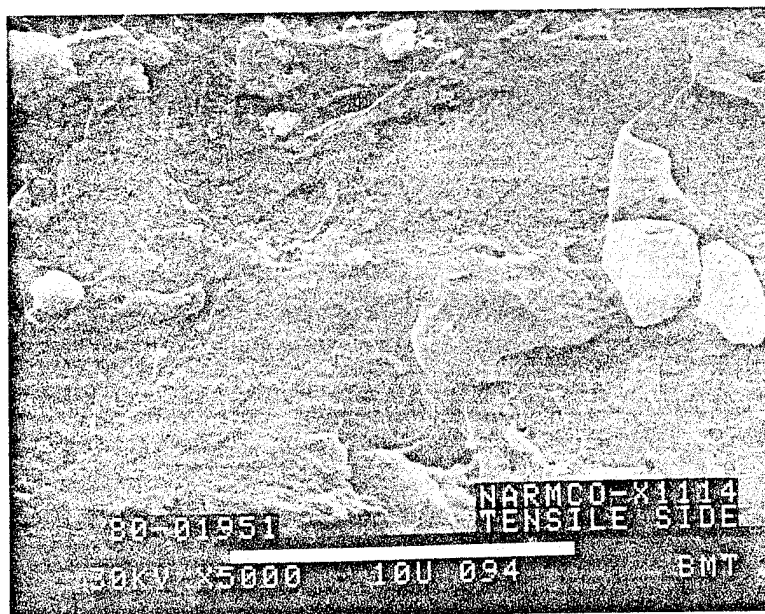
Figure 114. Fiber-Matrix Bond, Narmco X1114 (5000X)

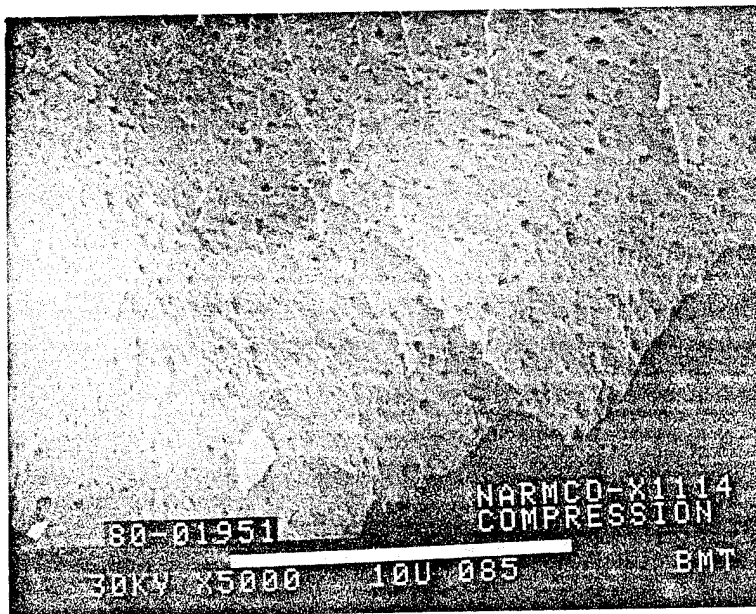
Compression-side shear faces are similar to the tension faces at low magnification, as shown in Figure 115. Figures 116 through 121 are at higher magnification and show an additional mode not found in the tension delaminations. While compression-side shear planes also support the large degree of plastic flow found in the tension faces, a feature similar to that of Hexcel I also is found. This feature is especially prominent in Figures 118 through 121. It should be noted, however, that the microstructural view of Narmco X1114 did not show the large amount of porosity that was evident in the case of Hexcel I. Therefore, it seems unlikely that the porous, spongy appearance of this resin is due to voids. Another similarity between the two specimens is that both have the same base resin, bisphenol-A. However, several other specimens, such as BP-907, also have bisphenol-A as a base and do not exhibit this topography. This leaves the additives and second resins as causative agents for this mechanism of deformation. No information is available to show a link between these materials and the deformation process, so the actual cause of this fracture structure remains unclear.

Figure 118. Deformation Pits in Flowed Resin, Narmco X1114 (5000X)
